Downtown Lighting and Signals Upgrade

Municipality of Anchorage Project No. 14-48

Reconnaissance Study

August 2018

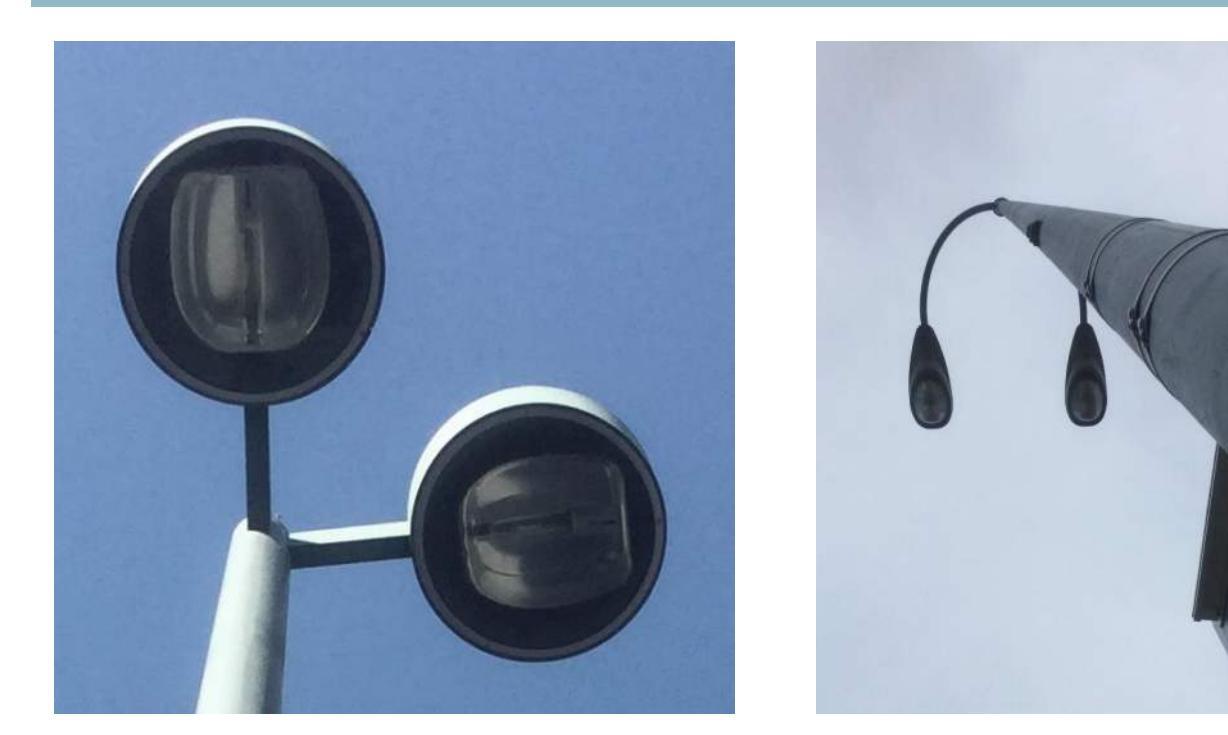
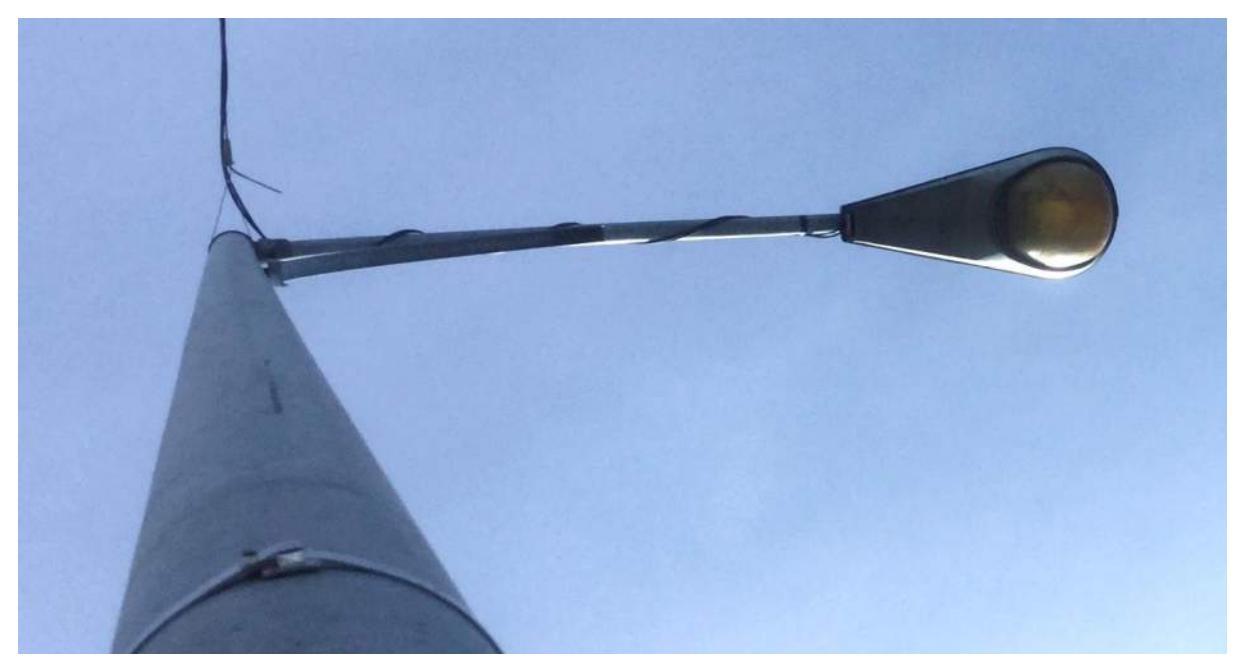
Figure 5 - Existing Street Light Fixtures

L Street Cobra Head (with overhead power feed)

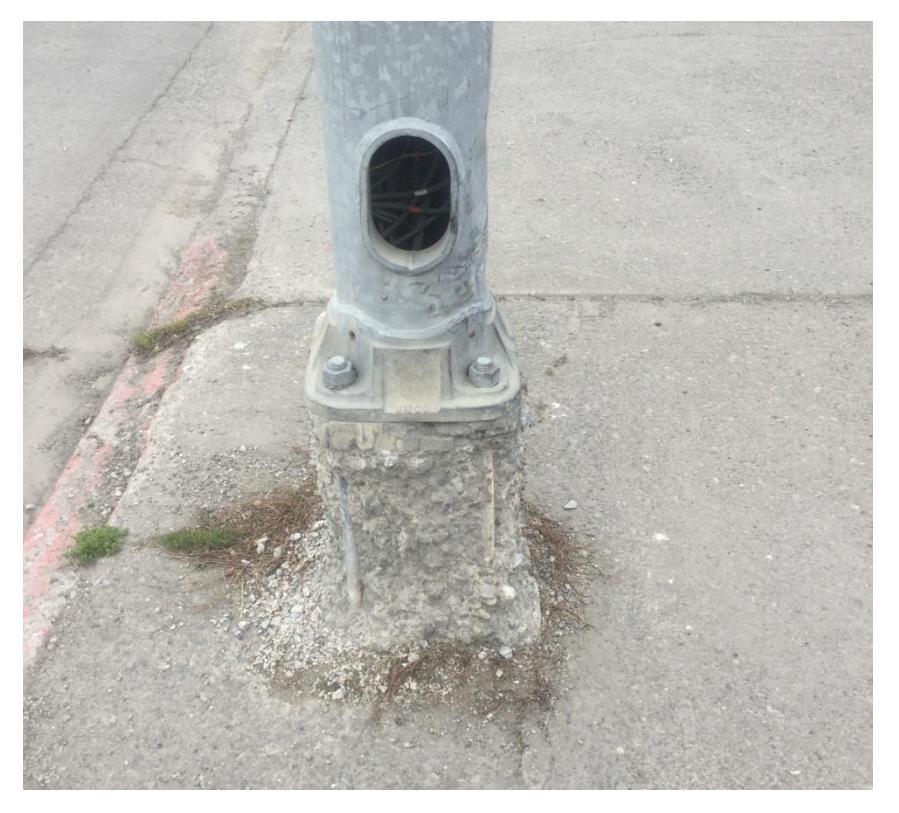
In addition to the condition ratings, we collected data on missing handhole covers. Throughout the CBD, 112 handhole covers were missing (as shown in Figure 6).

Figure 6 - Spalled Concrete Pier Foundation and Missing Handhole Cover

There are a number of deficiencies MOA should address as soon as practicable, including replacing missing pole handhole covers, installing junction box lid bonding jumpers, replacing certain load centers that have substandard grounding, and providing a load center for the traffic signal at 4th Avenue and C Street. These are the highest priority improvements recommended to reduce risks to the public and staff working on these systems.

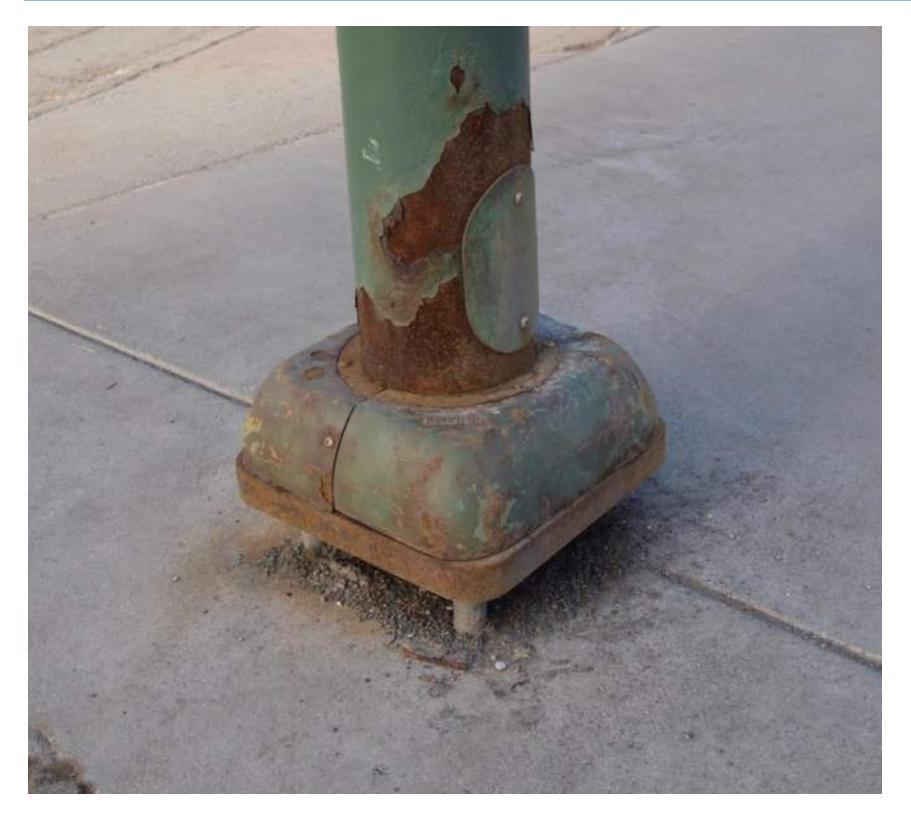
The poles in poor condition exhibited different wear depending on the type and age of the pole. The green poles with puck style heads had rust on the bottom 5 feet of the pole where abrasion or chemicals had worn off the paint. Poles mounted on pier block foundations showed signs of spalling, likely due to freeze-thaw conditions and deicing agents. Many of the pier-style foundations exhibit severe spalling. As a result, many of the anchor bolts are exposed (i.e., no longer embedded in the concrete), raising questions about their structural stability. The project team views pier style light pole foundations as a high priority for replacement. Galvanized steel poles with bases below or integrated into the sidewalk also showed signs of rust, wear from over-tightening (as evidenced through stripped bolt threads), and fatigue on the anchors. Anchor nuts were also observed to be loose on one or more anchor bolts, though not regularly. The anchor bolts along 4th Avenue showed the most signs of rust and wear, indicating higher need for replacement.

Figure 7 - Green Puck Light Pole with Rust

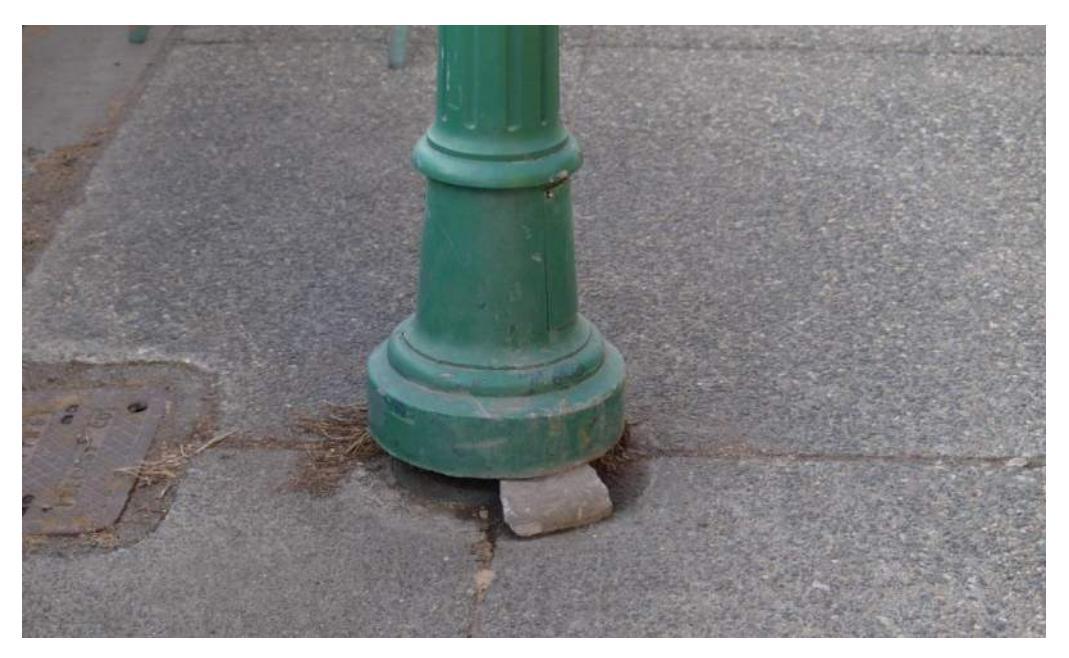
Figure 8 - Pedestrian Pole with Failing Foundation

style pre-cast light pole foundations were noted to be heavily degraded along 3rd and 4th Avenues. Pedestrian light pole anchor bolts and nuts were not visible along 4th, 5th, and 6th Avenues. Since most of the foundations are obscured from view (either entirely or partially), they were not subjectively rated. However, there have been reports of pedestrian light poles along 4th Avenue falling over due to failed anchor bolts. The failure mode was corrosion, which is consistent with the observed state of the underground conduit and junction boxes.

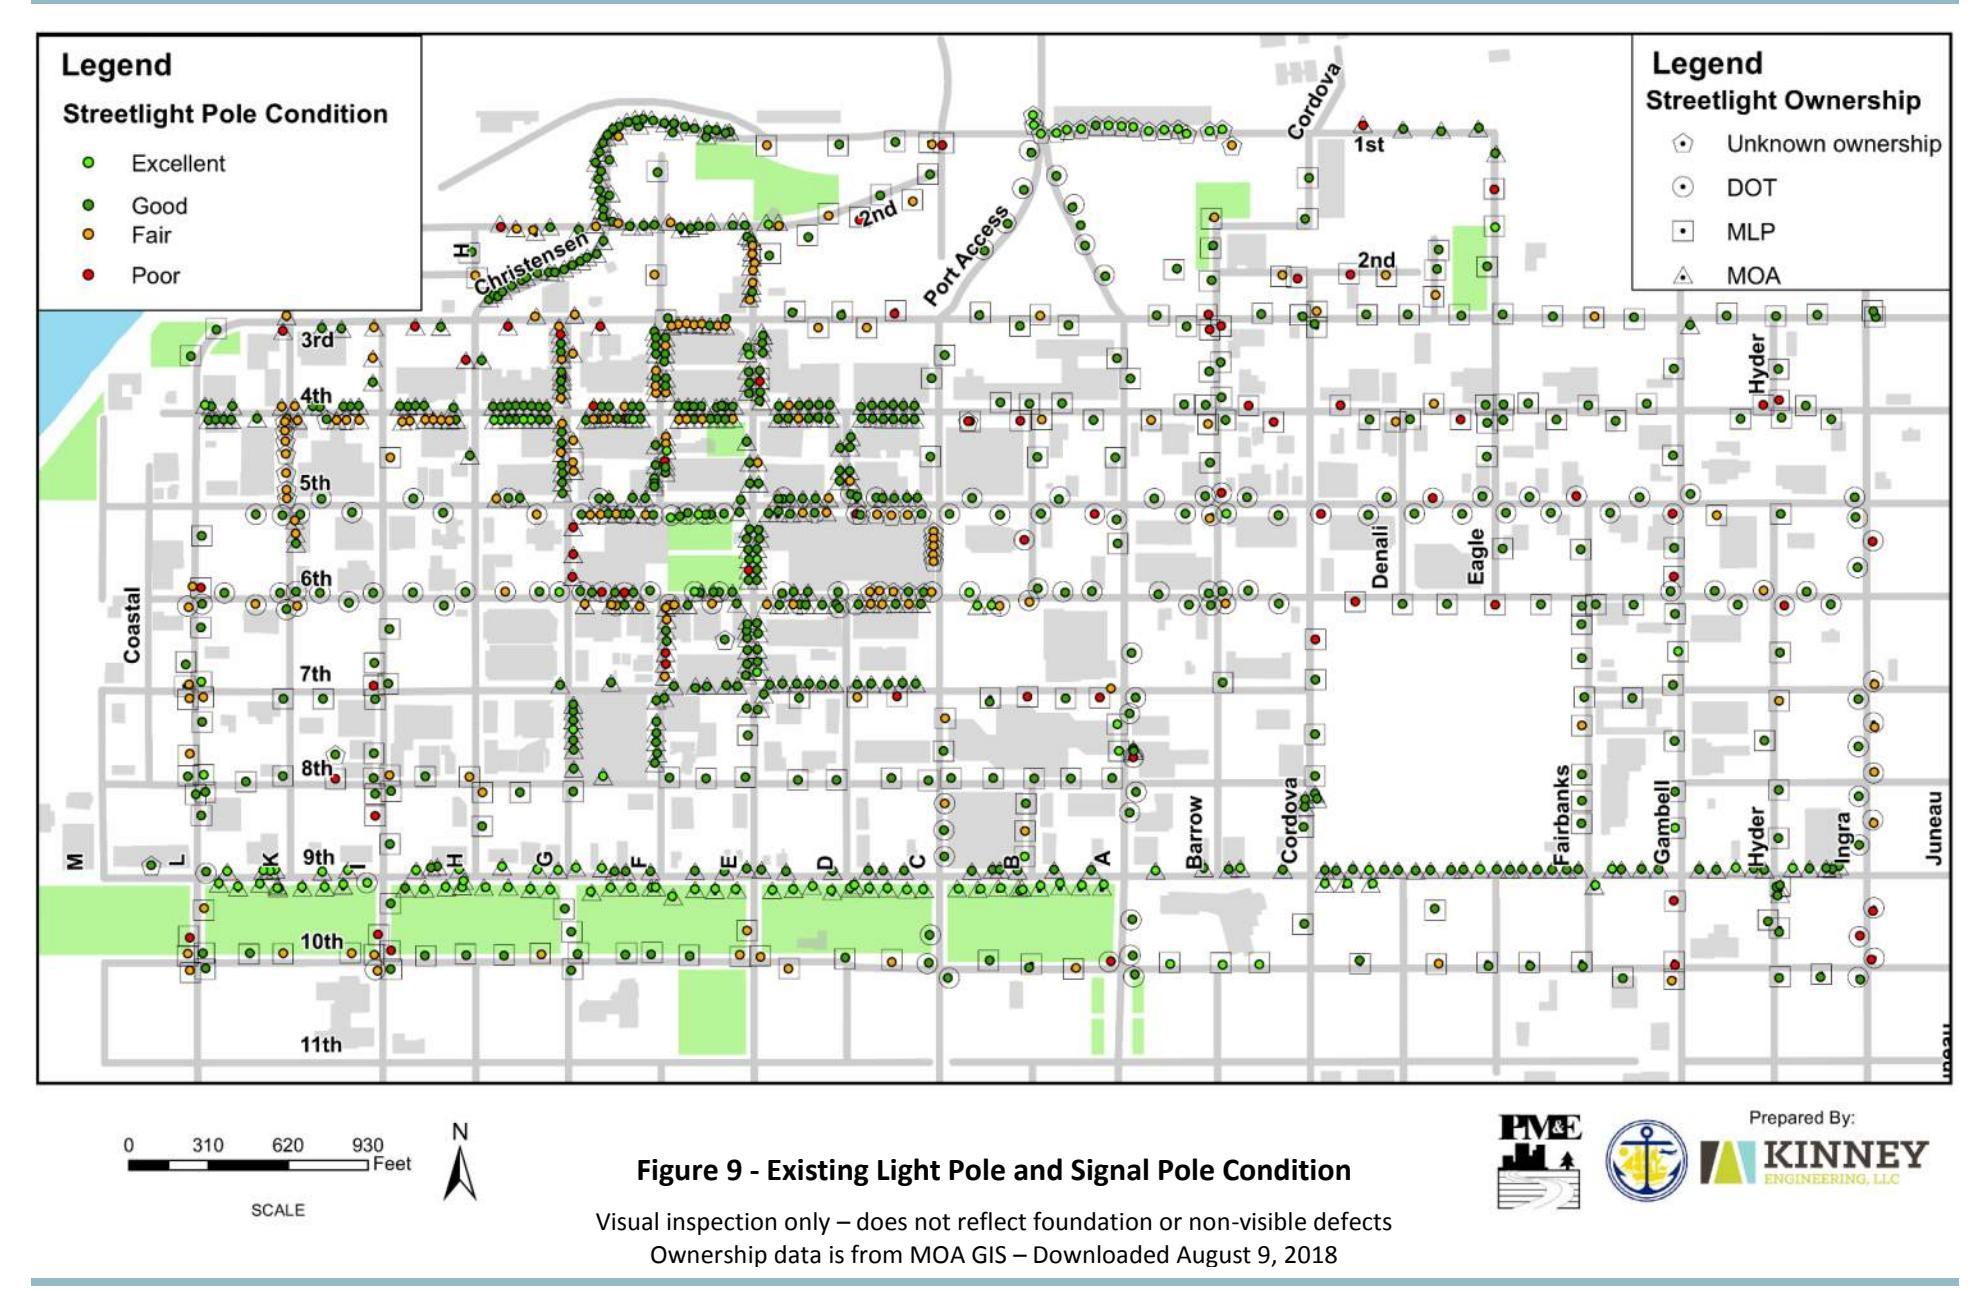
Figure 9 maps the light poles by condition and ownership. Ownership data was polled from the MOA GIS and not confirmed for this project. In addition, not all Municipal Light and Power (ML&P)-owned poles were inventoried for this project. MOA and DOT&PF have entered into TORAs that may shift responsibility for maintaining or paying for different lights. ML&P lights are generally paid for by MOA under a "flat rate" system, which is approximately \$2,250 per light per year.

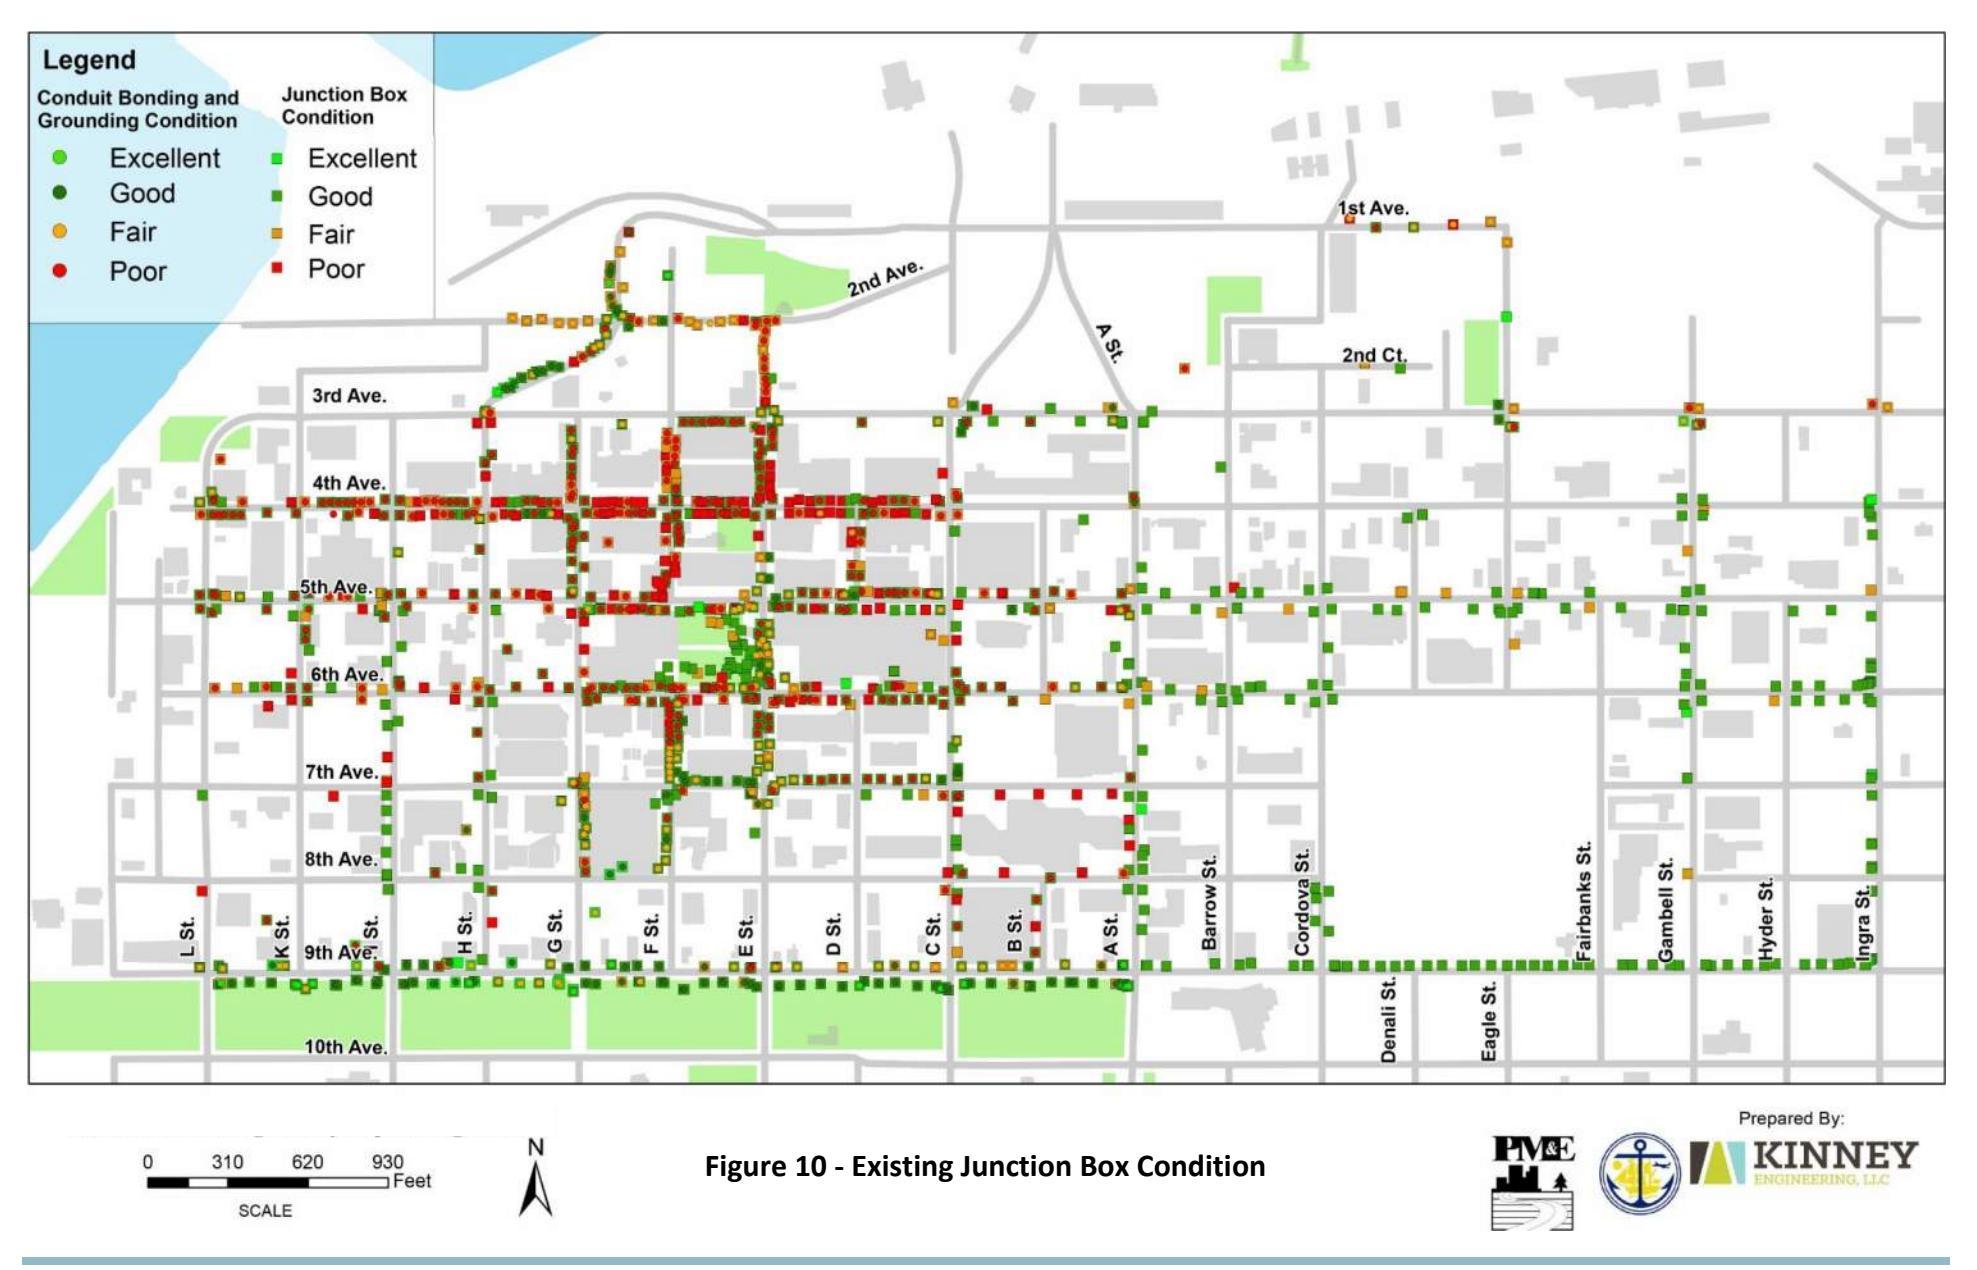
Junction boxes were inspected for the signs of damage and deterioration; such as cracked/broken ductile iron lids, failing lid supports, and cracked/crumbling cementitious junction box material. Table 3 shows the rated condition of junction boxes inspected. Figure 10 shows the junction box locations and associated rated condition.
