Downtown Lighting and Signals Upgrade

Municipality of Anchorage Project No. 14-48

Reconnaissance Study

August 2018

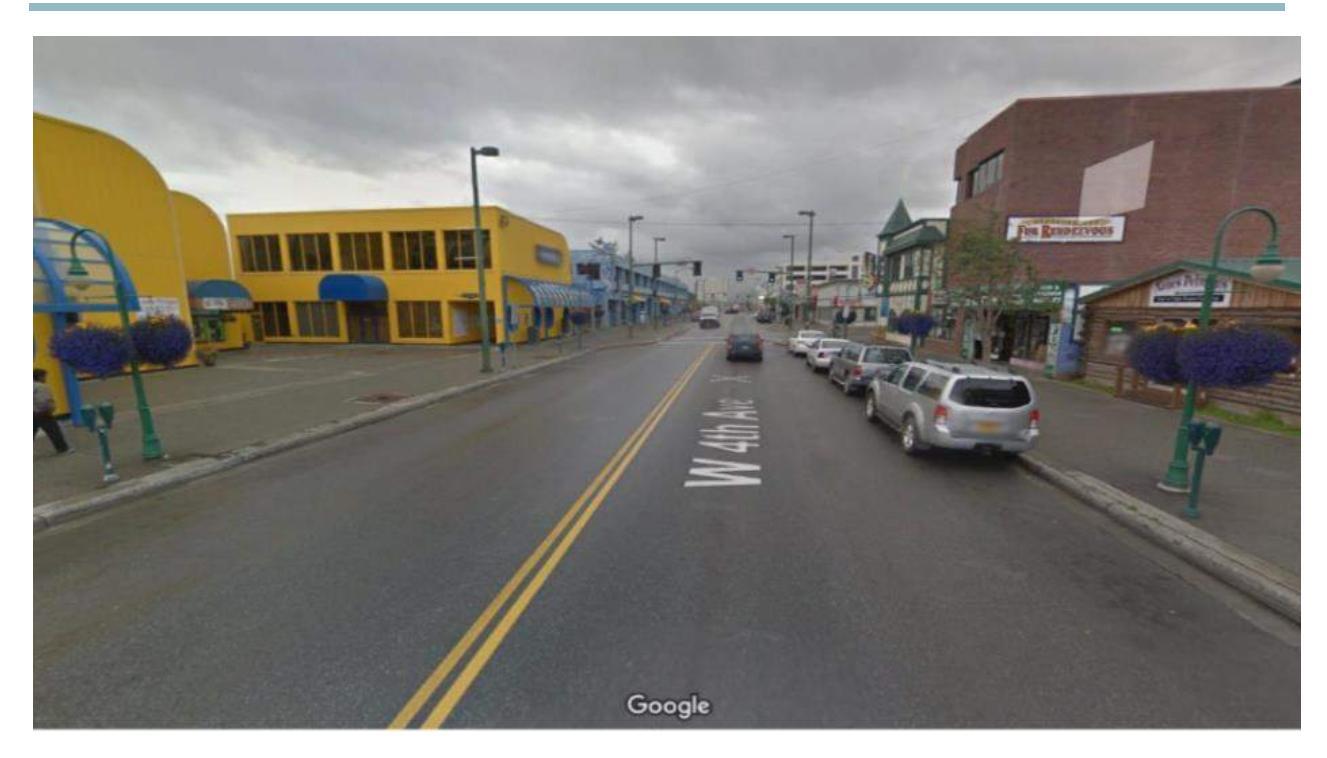
Figure 13 - 4th Avenue Street View

Based on the analysis cases, the illuminance levels generally meet standards throughout the project area. Uniformity is variable. Sidewalk lighting standards are not consistently met, and
